KARUAH BYPASS

FAUNA CROSSING REPORT

Prepared by David Bax
THIESS Pty Ltd
February 2006

Prepared for
RTA
Roads and Traffic
Authority
www.rta.nsw.gov.au

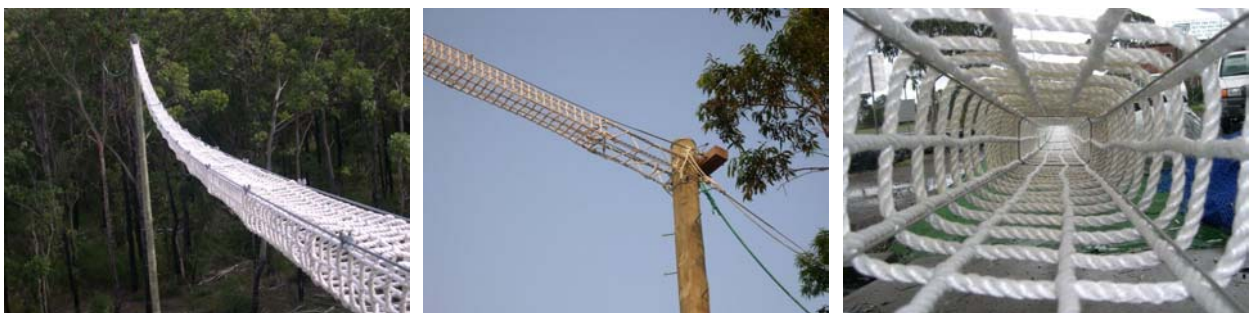
Figure 3. Close up views of a typical rope crossing.

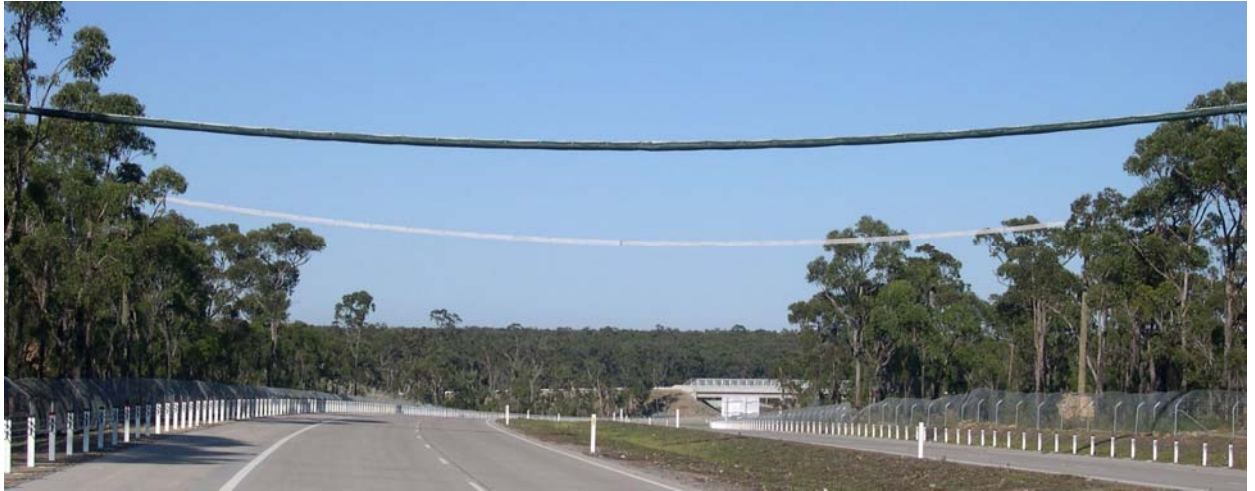
The poles were situated as close as possible to existing trees to encourage fauna use, and several ropes were draped to the poles from adjacent vegetation to further improve the likelihood of use.

Figure 4. Two of the rope crossings, one closed with headlight glare protection

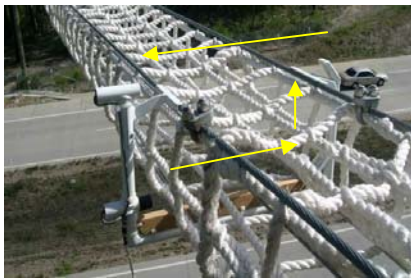
The sensor arrangement had to be designed to pick up movement both on the top of the rope tunnel and inside it. To achieve this, a pair of 45 degree mirrors were used. The IR beam would emanate from the lower left transmitter and shoot across the lower inside of the net before hitting the first angled mirror on the right hand side. It would then deflect up to the top mirror which subsequently deflected the beam back across the top to the receiver on the left hand side. Any interruption of the beam by fauna would trigger the camera to shoot. The sensor frame was mounted on to the rope structure in lieu of the pole because the rope bridge sways in windy conditions which would trigger the camera. By having the sensors sway with the bridge, there is no relevant movement.

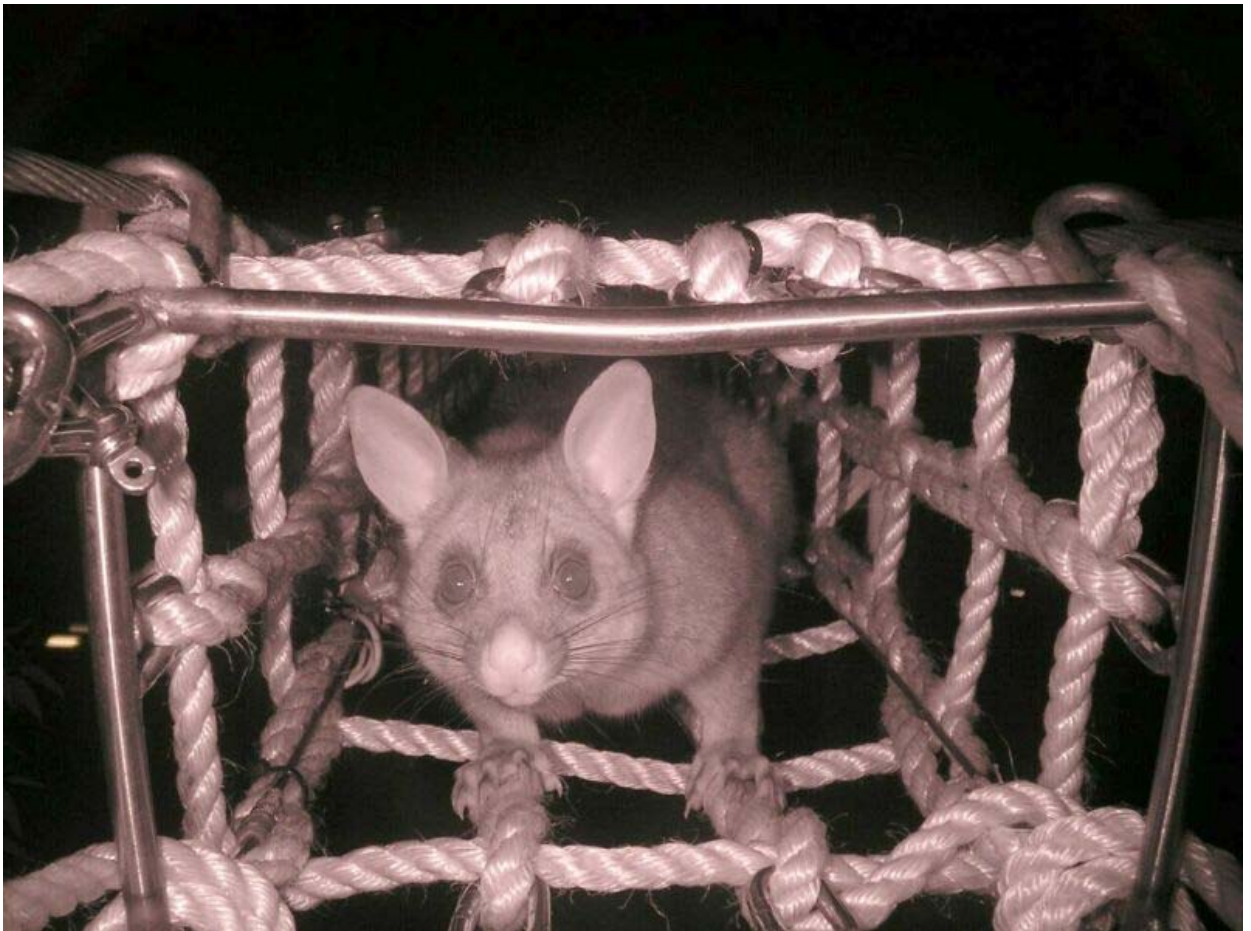
The image in Figure 5 was captured within hours of commissioning the camera on Day 1.

Figure 5. Brushtail possum using the inside of the rope tunnel

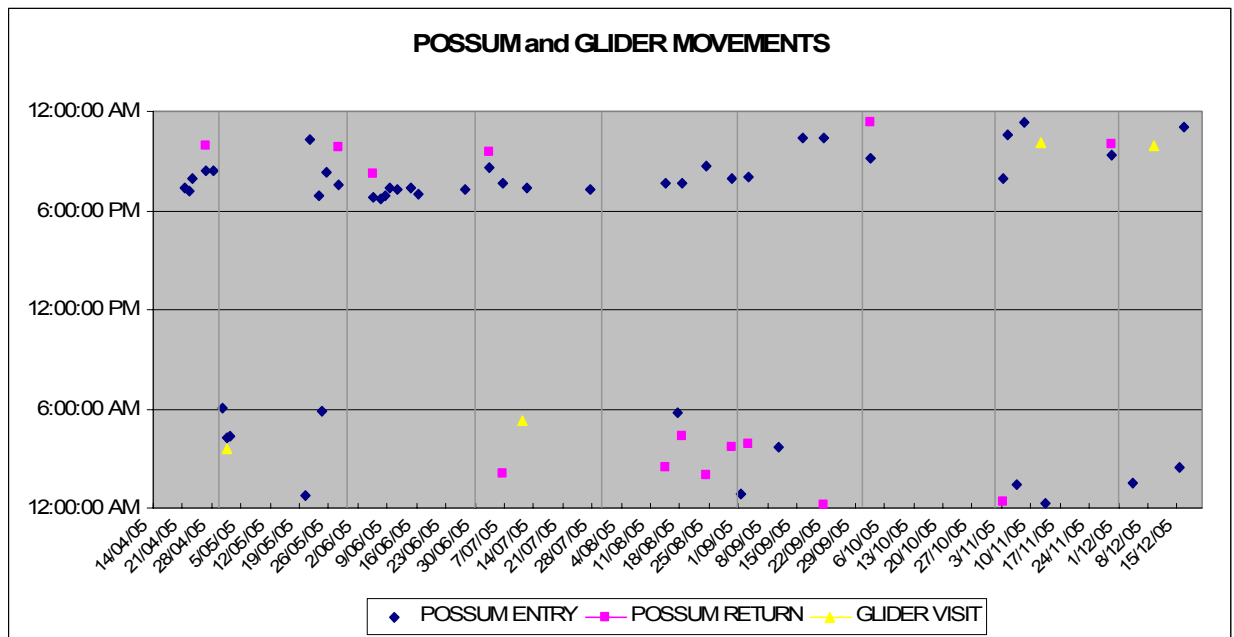
Of the 50 crossings, 46 were from a brushtail possum and 4 were from a squirrel glider. Figure 6 graphs the time and dates of each of the crossings.

Figure 6. Graph of crossing times and dates

Most of the crossings originated between 6.30pm and 8.30pm. All crossings were completed by 6.00am. It was possible to tell conclusively on a number of occasions that possums came across the rope bridge from the far side, jumped on to an adjacent tree near the camera, and after varying amounts of time jumped back on to the crossing and returned across the bridge. The photos in Figure 7 demonstrate this typical behaviour.

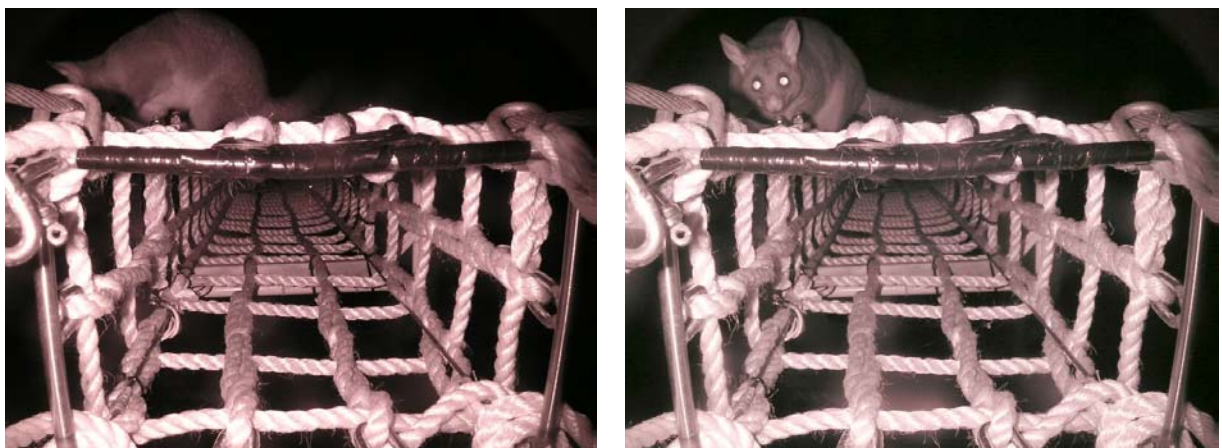
Figure 7. Brushtail possum exiting to an adjacent tree and returning afterward
