1. WEED SURVEYS ALONG HIGHWAYS, ROADS AND POWERLINE CLEARINGS TRAVERSING THE WET TROPICS WORLD HERITAGE AREA

Miriam Goosem

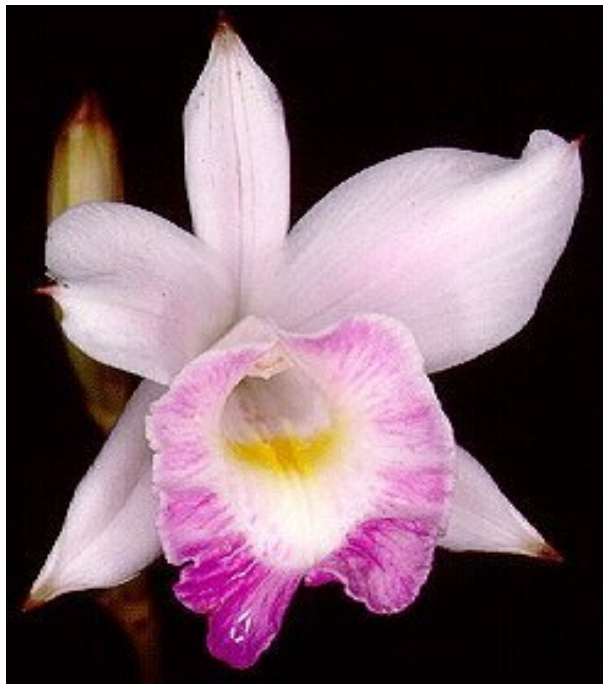
The flowers found along the Suttie's Gap road (Figure 1.5) are rose-purple or white and a few centimetres across, the lip is darker than the sepals and petals, they are often veined purple and have a yellow patch at the base. The species blooms all year and one plant bears many flower spikes.

Figure 1.5: *Arundina bambusaefolia* flower.

Bruce Gray (pers. comm.) recommends that it should be removed from the site and the location monitored for several years, as seed may have been set during the two years that it has been known to occur at this site (Rigel Jensen, pers. comm.).

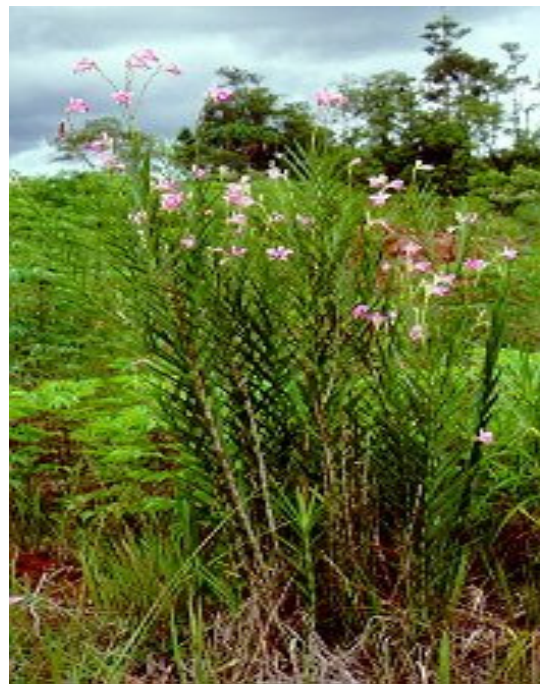
Figure 1.6: Growth form of *Arundina bambusaefolia*.

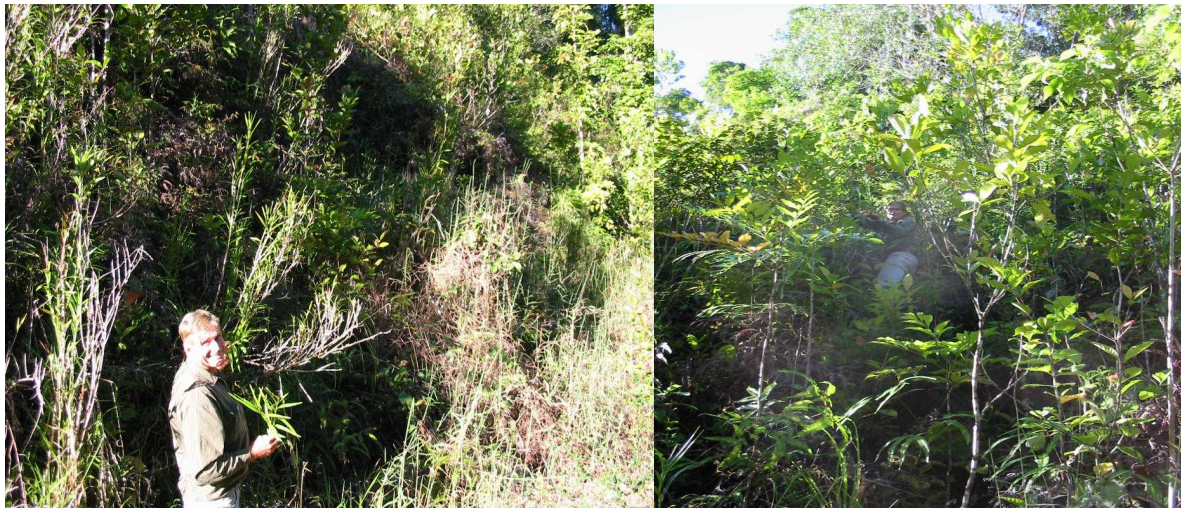
There are many individual plants present along the road cutting for approximately fifty metres, suggesting that the species is at least vegetatively reproducing and very probably seeding also.

Figure 1.7: *Arundina bambusaefolia* on a road cutting west of Charappa Creek forestry camp clearing.

Removal of the plant should only require one vehicle with several people and equipment to allow safe climbing of the road cutting and the digging out of the plants. Replacement with native ferns such as *Dicranopteris linearis* or tree ferns would be preferable, to prevent colonisation by alternative weeds.

- Removal of the new weed species, *Arundina bambusaefolia*, which was found along the South Johnstone road network, should be undertaken as soon as possible, as elimination of this weed is currently achievable.

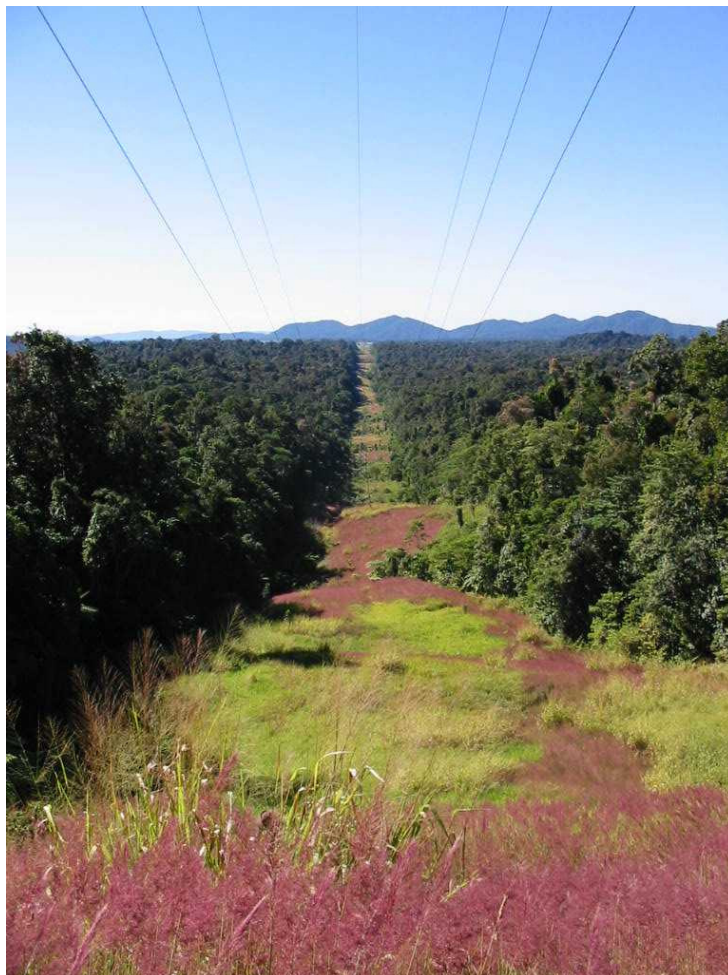
Figure 1.8: Lower section of Palmerston powerline clearing illustrating swathes of molasses grass (purple flowers), signal grass (bright green in foreground) and Guinea grass (taller pale green in foreground). Note small amounts of regrowth in gullies in middle distance.

In summary, the general ecological condition of the Palmerston powerline clearing is extremely poor, being dominated by grassy swathes and lantana. In sections, particularly along the H Road and the Tully Gorge escarpment, and to a lesser extent along parts of the Maalan Track and West Palmerston Track, long forested connections where the powerline swings above the canopy, together with the small tower footprints leads to a relatively good ecological condition rating. However, even in these sections, weeds infest the tower sites. The lower elevation sections near the Palmerston highway, K-Tree Track, Jordan Goldfields Track and the Tully River are mostly in extremely poor condition. However, there has been a change in ecological condition since fires were excluded over the past few years. In some cases that has resulted in one weed type (woody) overtaking another (grass), but in others it has allowed regrowth forests along gullies to grow taller and the extent of these regrowth patches has increased, thus improving ecological condition.

- Although parts of the Palmerston powerline clearing are currently in poor ecological condition, restoration work across the clearing, such as that undertaken by the Centre for Tropical Restoration, and extension of the natural regeneration in gullies is improving this situation gradually. Further restoration works could speed this recovery. As this is an area of high biological diversity, vegetation complexity and the habitat of many species of rare and threatened fauna and flora, it is considered a high priority for restoration. Removal of the powerline infrastructure will aid in the recovery by allowing further restoration works as well as the natural regeneration to proceed without concerns for safety.

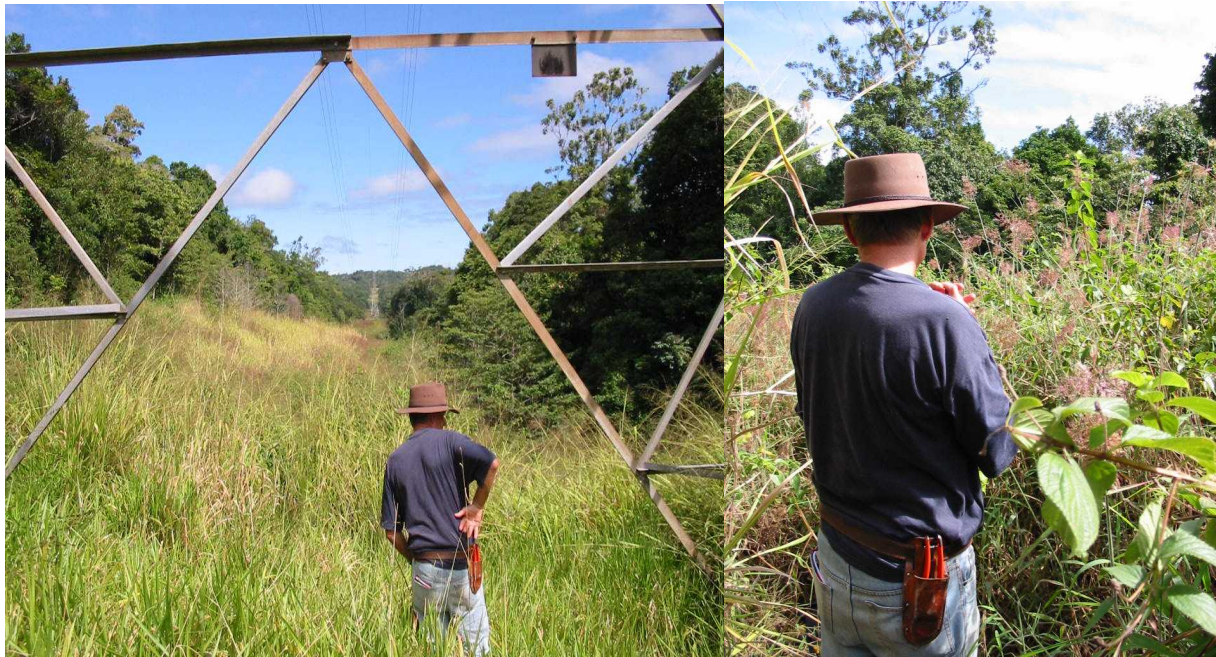
Figure 1.9: Upper section of Palmerston powerline clearing illustrating a Guinea grass swathe and areas where Lantana is expanding through the grass in the centre of the clearing.

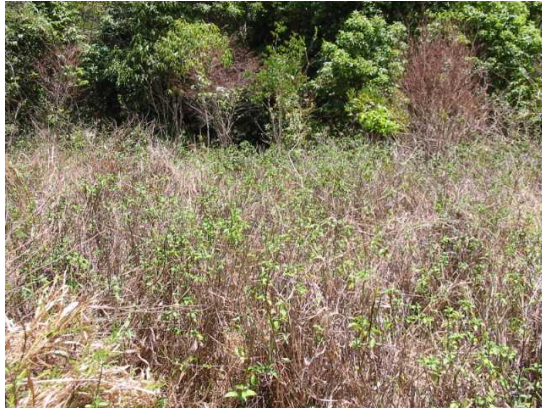
The lower elevation swathes of the Chalumbin-Woree powerline clearing, where Bridle Creek runs parallel to the clearing, are mostly heavily weed-infested. The adjacent forest is relatively dry and the dryness is reflected in the clearing vegetation that consists mainly of

Figure 1.10: Chalumbin-Woree lower elevation swathes of grass and blue snakeweed.

- Weed control and restoration work, together with the exclusion of livestock, is required in the western sections of the Chalumbin-Woree powerline and road network, to improve the ecological condition of the area.

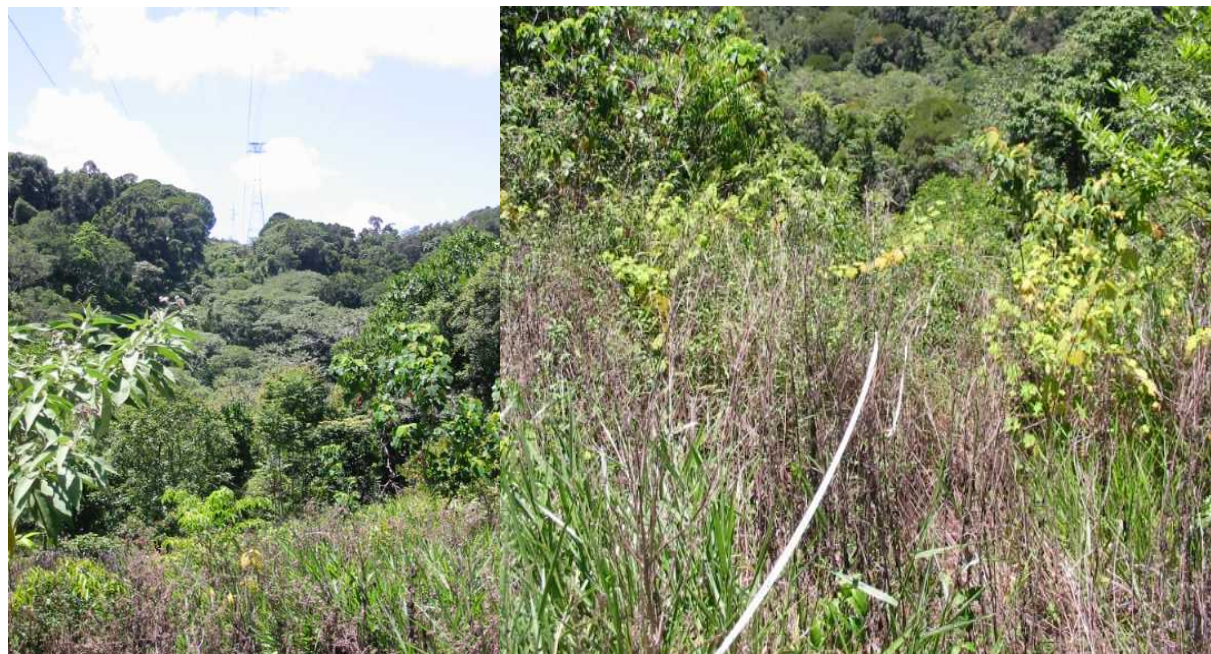
As the powerline climbs, wet-adapted grasses such as Signal and Carpet grass take over, while the herbaceous weeds, particularly Blue Snakeweed and Bluetop, remain common, with lantana still forming dense thickets. Forested connections become more common with clearings around the towers reducing in size and weeds therefore becoming less dominant.

Figure 1.11: As the powerline climbs, forested connections become more common; clearings around towers are still dominated by grasses adapted to wetter habitats and woody weeds.

- Encouragement of the extension of swathes of low native species to replace weedy swathes using selective weed control along the Chalumbin-Woree powerline corridor, particularly at higher elevations, and along the Lake Morris Road, should result in excellent gains in ecological condition whilst retaining safety aspects crucial to the power distributors.
